HVOF Coatings at Hill AFB

13. SUPPLEMENTARY NOTES 23rd Replacement of Hard Chrome Plating Program Review Meeting, November 18-19, 2003, Cape Canaveral, FL. Sponsored by SERDP/ESTCP.

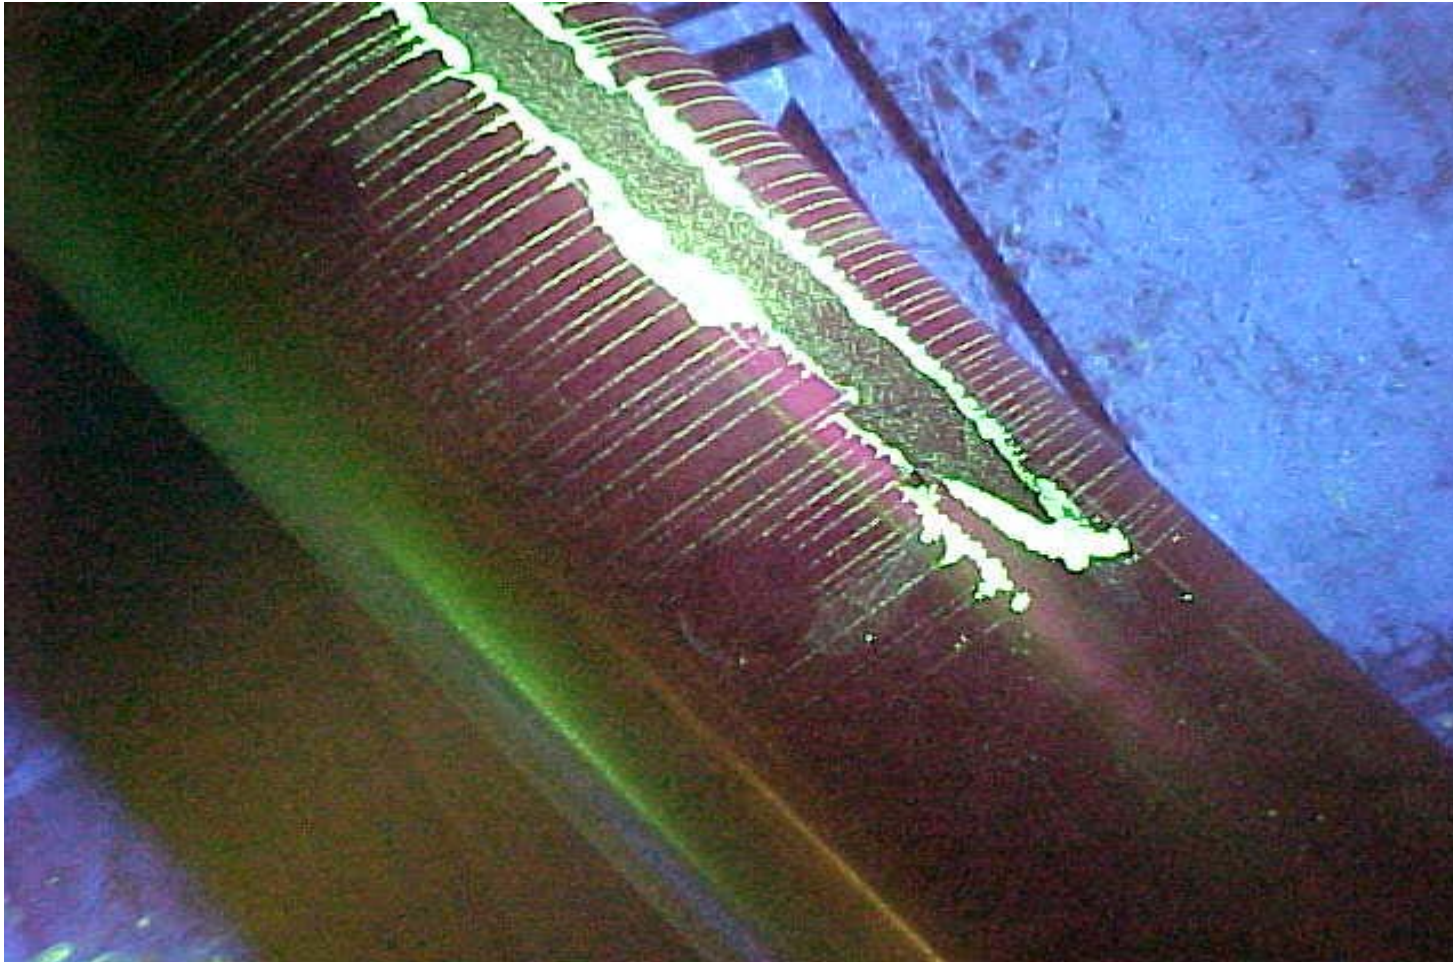
Appearance of Cracks in Coating and Spalled Zone

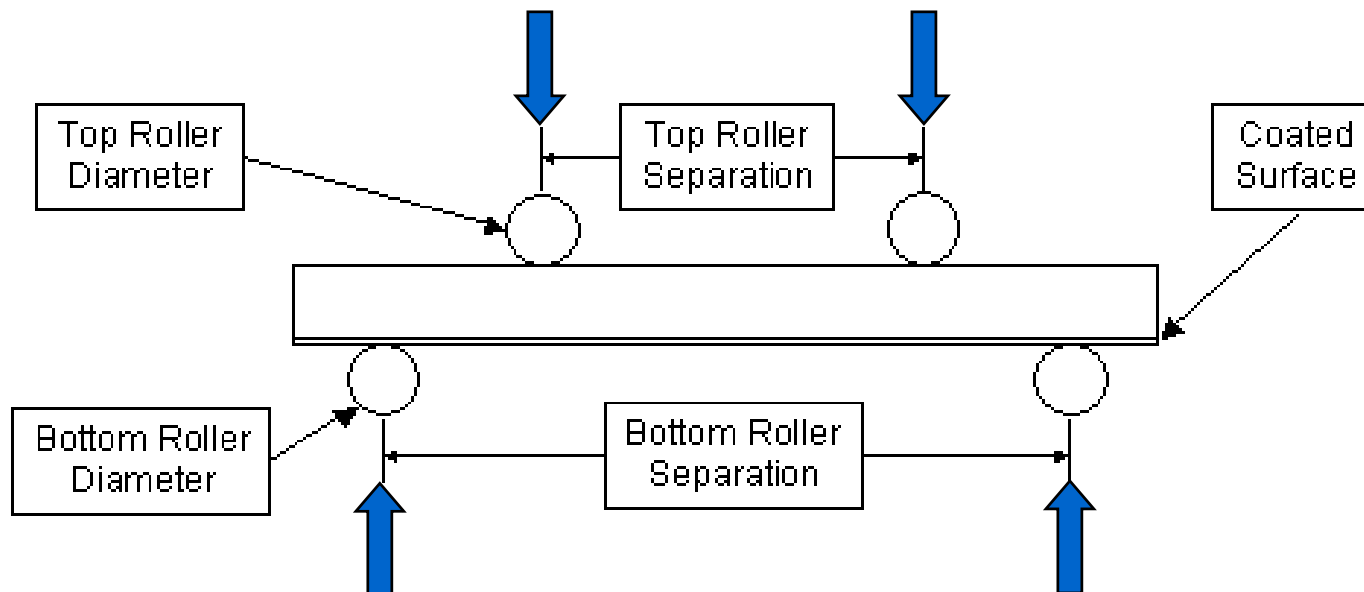
- Working with Praxair Surface Technologies (Dr. Daming Wang) to investigate duplex coatings for thick build-up repair of landing gear components
- Using 4-pt bend beams(300M) to study strain to fracture and spallation

4-Point Bend Test Schematic

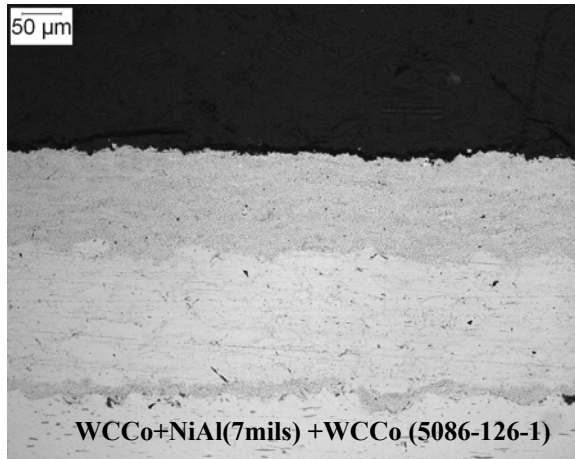
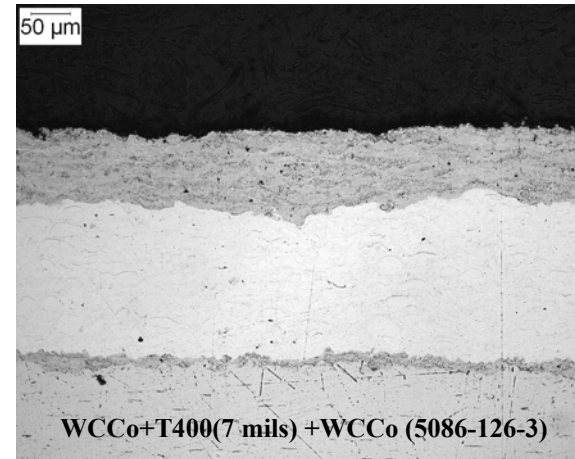
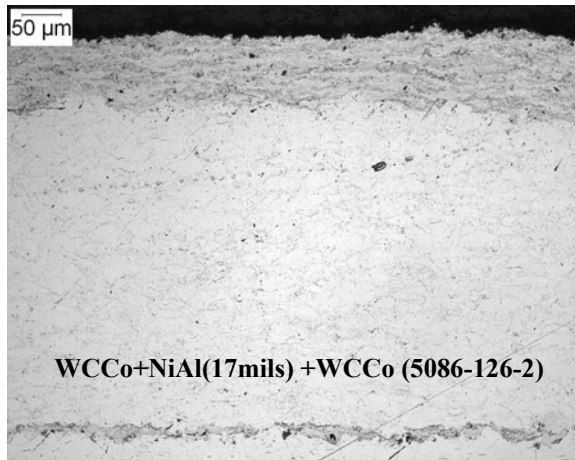
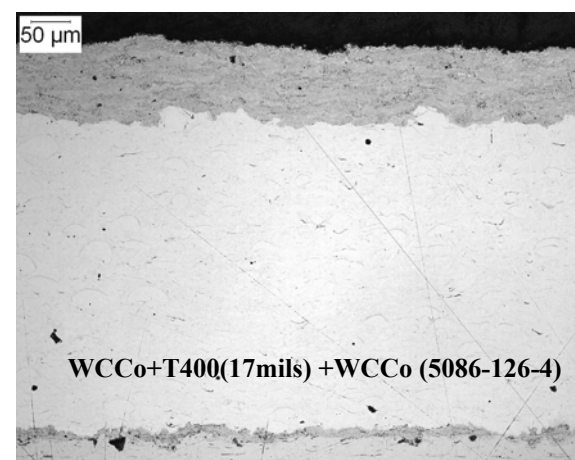
- **Coatings applied via HVOF process on 300M bar**
 - **Replacement for sulfamate nickel build-up and cap with chrome plating**
 - **Bond coat(WC-17%Co)**
 - **Build-up coat(Ni-5%Al and T-400 investigated)**
 - **Topcoat(WC-17%Co)**
- **Benefits**
 - **No surface prep required after each coating application**
 - **One booth, Two powder feeders**
- **Investigating local(patch) repair**

HVOF Duplex Coating Microstructure

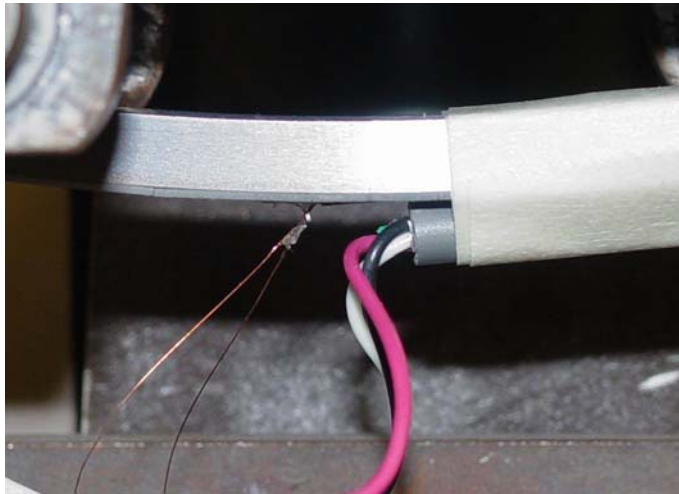
Spalling of Thick Duplex Coating

Detection of Spallation Initiation
During Loading

WC17Co+T400+WC17Co (0.020")
(1343VM+CO109-7+1343VM)

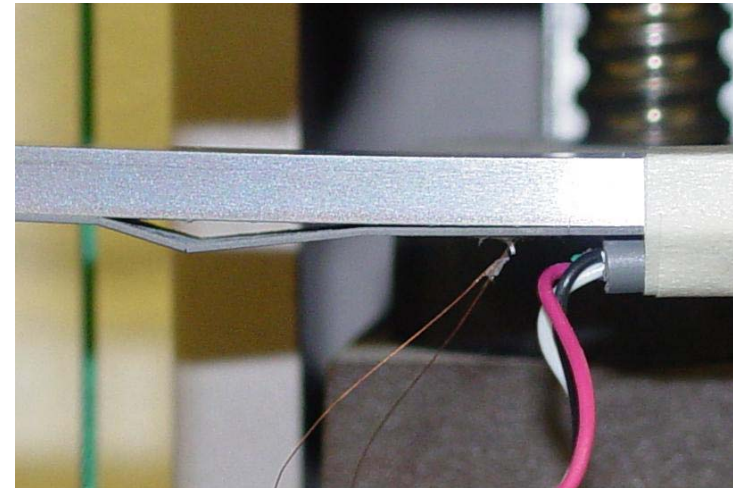
Spallation When Load is Removed

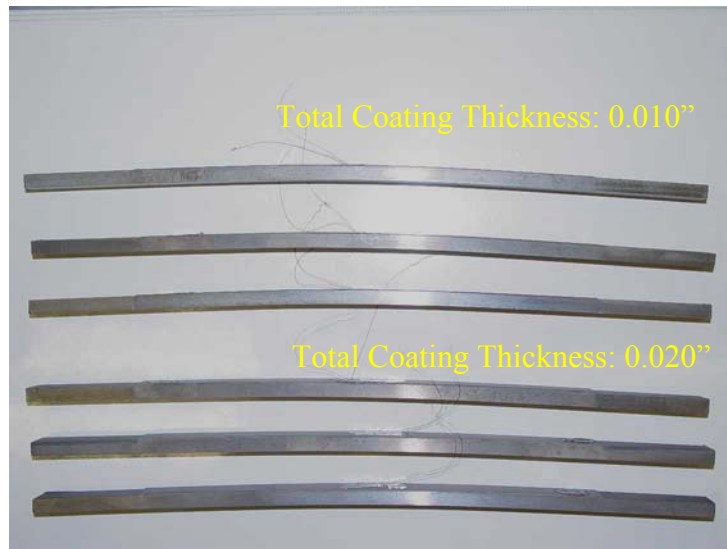
4-Point Bend Test Specimens with Duplex Coating Systems

WC17Co+Ni5Al+WC17Co
(1343VM+NI-356-7+1343VM)

- **Significant improvement using duplex coating system**
 - **Spalling resistance increase**
 - **Applied bending stress above Yield Strength**
 - **Substantial permanent deformation observed in bars after test**
 - **Crack indications observed in top coat**
 - Investigation on-going
 - **Ni-5%Al appears to be the winner for build-up coat**
 - Deposition efficiency higher than WC-17%Co
 - Lower powder cost
 - Weighs less than WC-17%Co
 - Can be sprayed via HVOF process(1 booth set-up)
 - No surface prep required between coating processes
- **Further investigation being conducted on duplex coatings**
 - **Local (patch) repair**
 - **Fatigue testing**

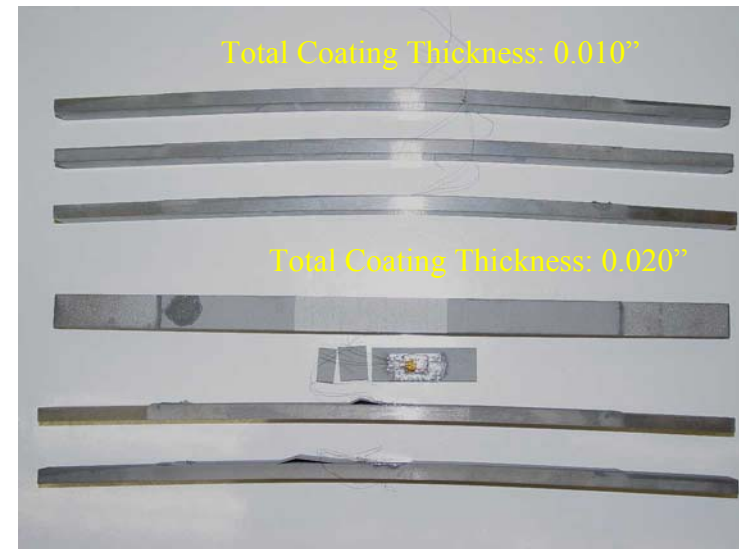
WC17Co+T400+WC17Co
(1343VM+CO109-7+1343VM)
